City of Fredericksburg, Virginia

Historic District Handbook

Prepared by:
Office of Planning
& Community Development

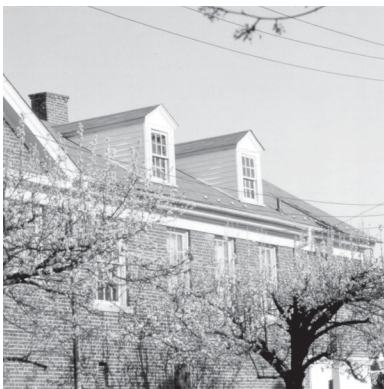
These dormers exhibit a material other than the original slate, which has noticeably changed the building's appearance.

More problematic are smaller changes that occur when necessary building maintenance takes place. At one time, for example, there was a Fredericksburg style of dormer that was characterized by roof shingles on the dormer sides. This type of dormer survives on many local buildings, but when worn slate roofs are replaced with less expensive roofs, any existing dormers are often resided in wood. Some owners try to maintain an historic appearance by using a Colonial looking beaded siding, but this effort invariably creates a false historic impression.

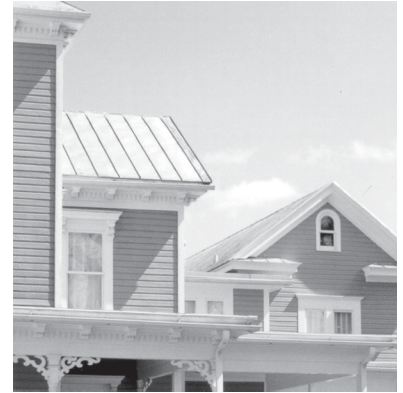
The original structure (left) is subtly, but clearly different from the addition (right).

Another example of avoiding false historic impressions is seen at 513 Princess Anne Street. Renovation of this property included removal of asphalt shingles which revealed extremely deteriorated weatherboards underneath - beaded boards on the main structure and plain boards on the rear addition. Rather than putting only one kind of new siding on the entire house, the owner conscientiously installed new siding that was consistent with the original weatherboards so the history of the building would remain apparent.

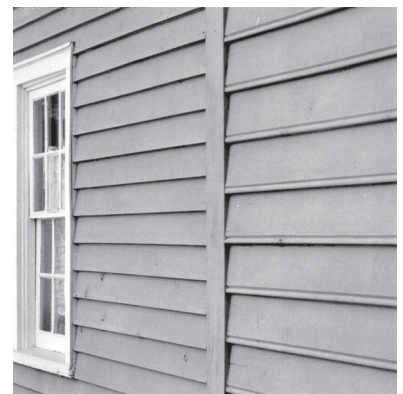
Repaired siding that adheres to the configuration of original materials maintains this building historic's integrity.

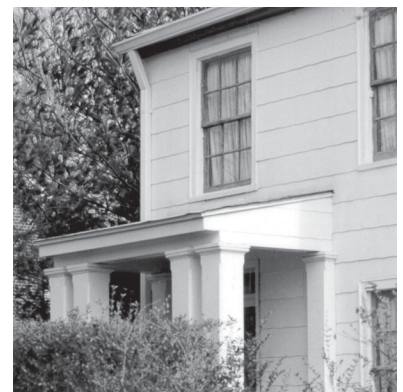
Porch columns from a larger structure are somewhat out of place on this smaller dwelling.

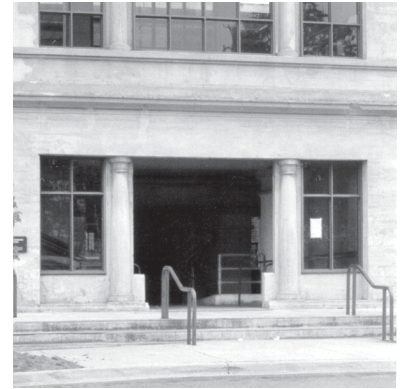
Access was enhanced to the rail station with minimal alteration to historic fabric.

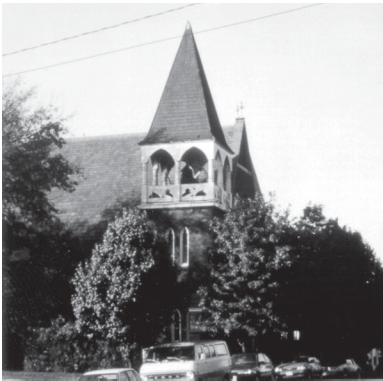
A carefully restored bell tower.

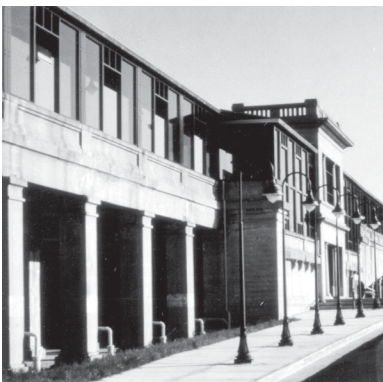
A blend of historic masonry fabric with contemporary windows.

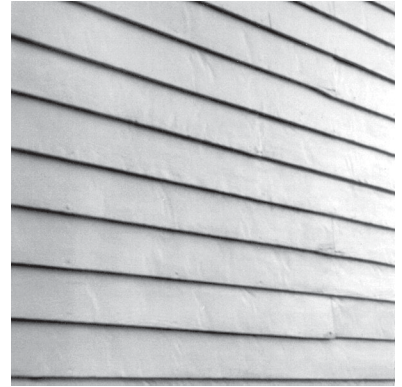
Rotary sanding damage.

This standard has a procedural application rather than being related to a building's design. Its purpose is twofold. First, work done in a manner to protect a building's fabric avoids shortening the life span of the building materials by inadvertently damaging them. Sandblasting, for example, will remove the glazing on bricks and cause them to rapidly deteriorate during normal weather cycles. Second, improper cleaning can give a false historic impression. Rotary sanding of Colonial era weatherboards, for example, becomes noticeable as an anomaly because rotary tools were not available during that period.

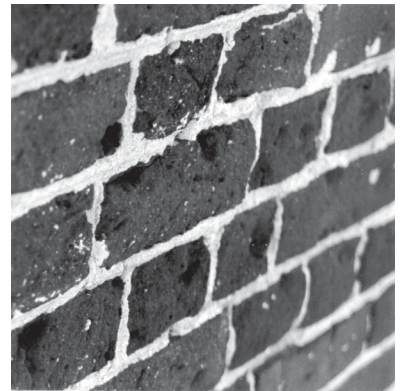
Sand blasting damage.

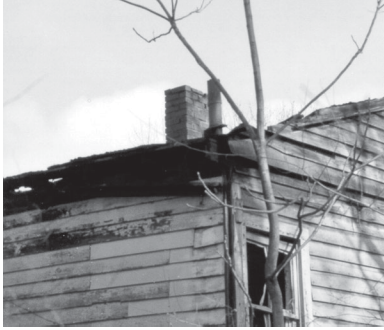
Once a roof is allowed to admit water, deterioration will rapidly follow.

1. Inspect roofs periodically for signs of deteriorated roofing materials as well as deteriorated or improperly functioning flashing, gutters, and downspouts.
2. Ensure the coping on top of parapet walls is watertight.
3. Keep gutters and downspouts clear of debris to ensure they function properly to move water away from the building. Cleaning gutters two or three times in the Fall and once again in the Spring is a basic first step in preventing leaks, deterioration, and even basement seepage.

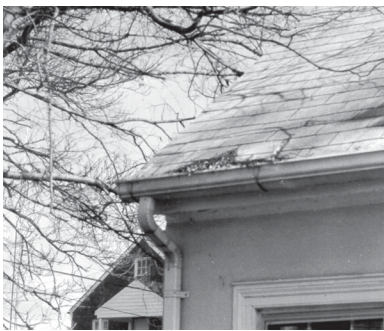
Gutters cannot function when blocked.

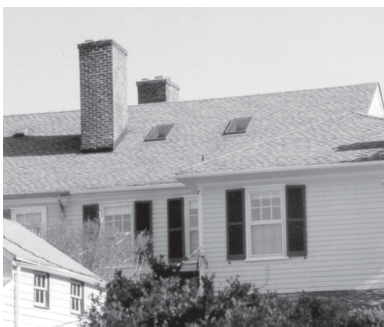
Skylights are useful but should be placed to be inobtrusive to the main elevation.

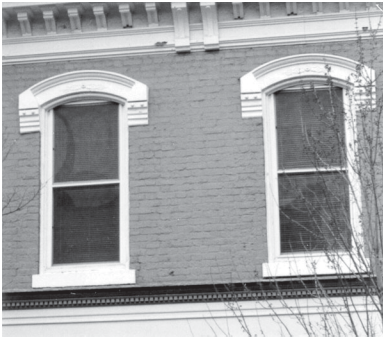
Inappropriate new windows.

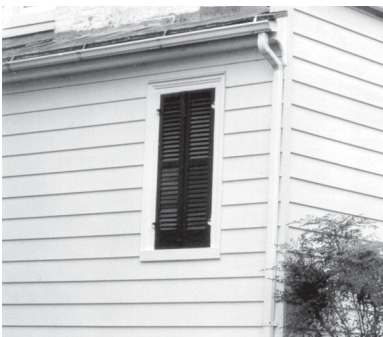
Covered window.

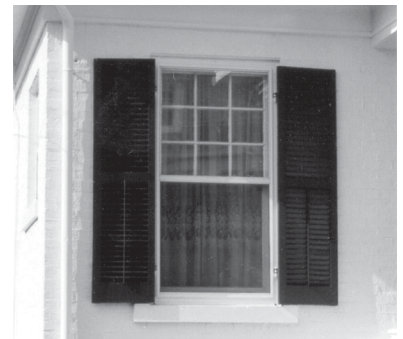
Appropriate storm window.

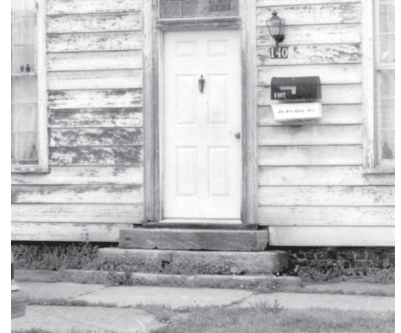
Inappropriate replacement door.

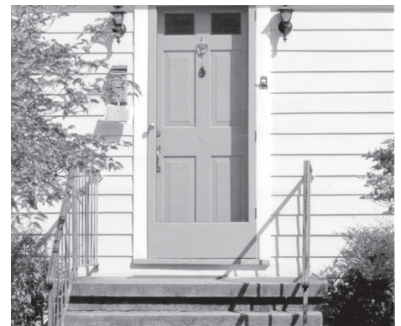
Appropriate storm door.

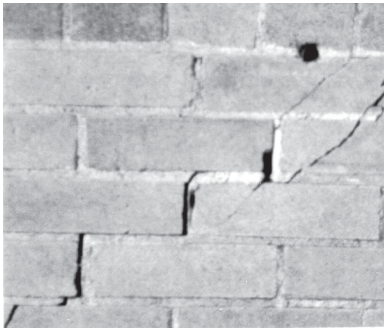
Cracked masonry.

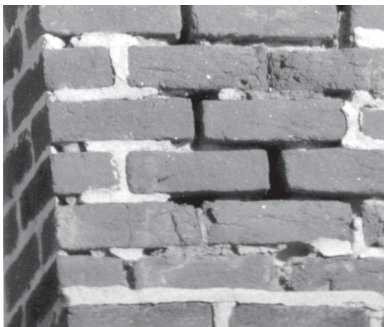
Loose mortar.

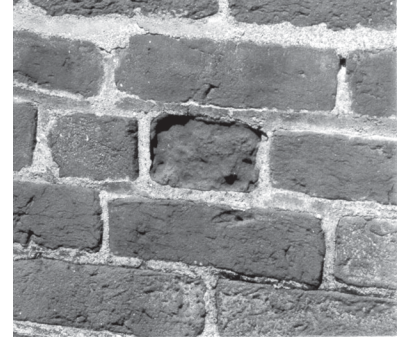
Spalled masonry.

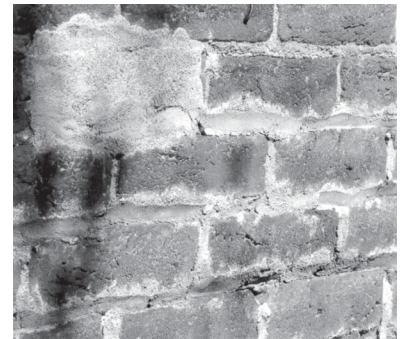
Poor repairs.

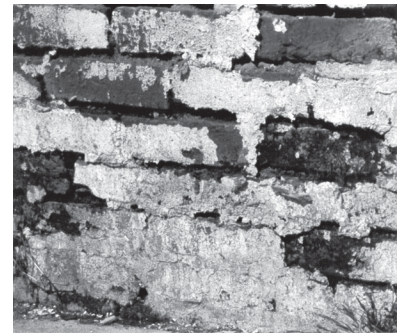
Damp masonry.

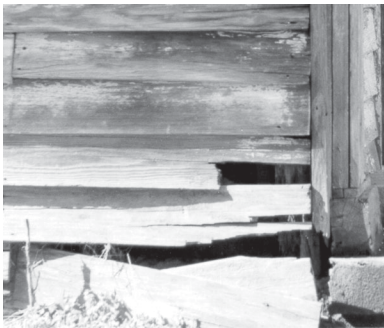
Deteriorated wood.

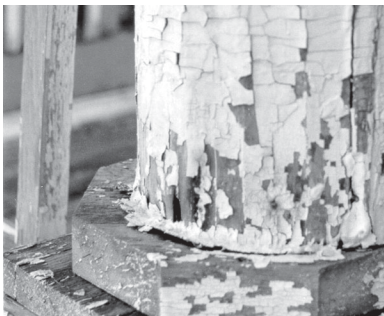
Deteriorated paint.

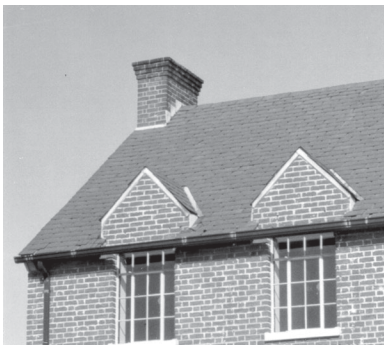
Iron or steel can be identified with a magnet and are found in everything from fences to roofs.

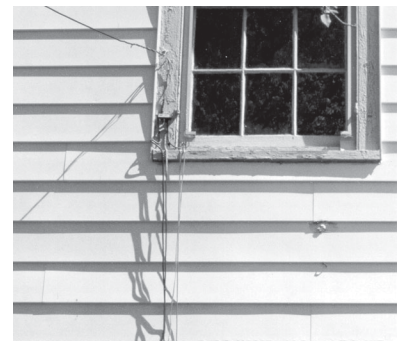
Loss of architectural detail occurs when brackets and decorative elements are sawn off to facilitate installation of the synthetic siding (which requires a flat surface to which it can be nailed).
